Manhole Inspection Summary

Manhole # S31UU1003MH

Location Address: **110 HOMELAND AVE**

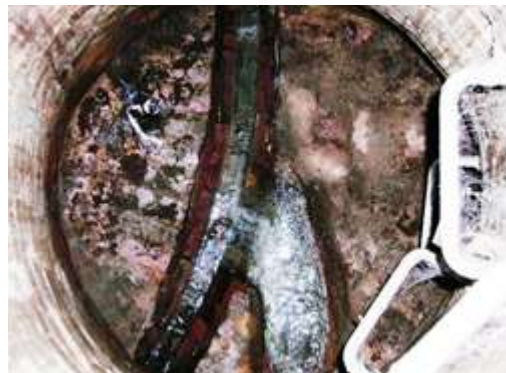
Top View

Bench debris.

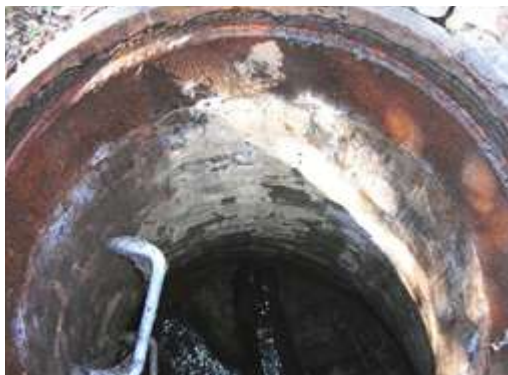
Defect

Frame leaks. Adjustment deterioration and infiltration. Corbel and Barrel infiltration.

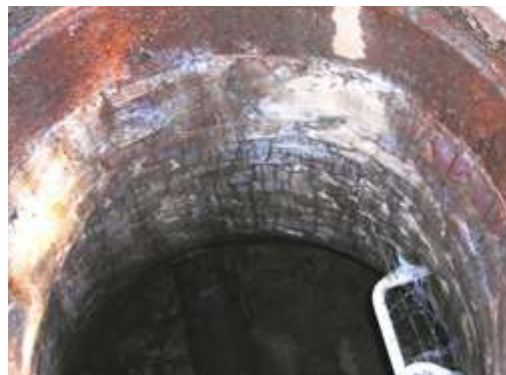
Defect

Adjustment deterioration and infiltration. Corbel and Barrel infiltration - other side.

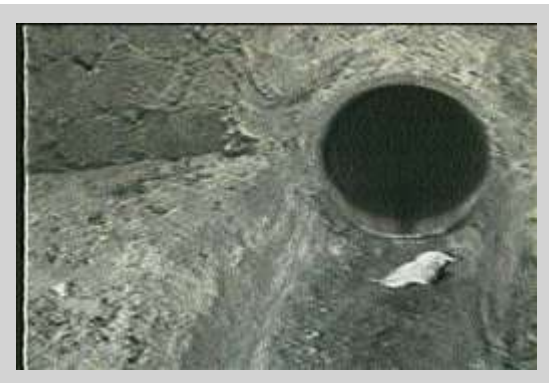
8 in. Circular Gravity Sewer Pipe In @ 5 O'Clock

Deposits: ☐ None ☐ Mud ☐ Sludge ☐ Debris ☒ Grease

Silt Depth: **0** (in.) Deposits Extent: **Light**

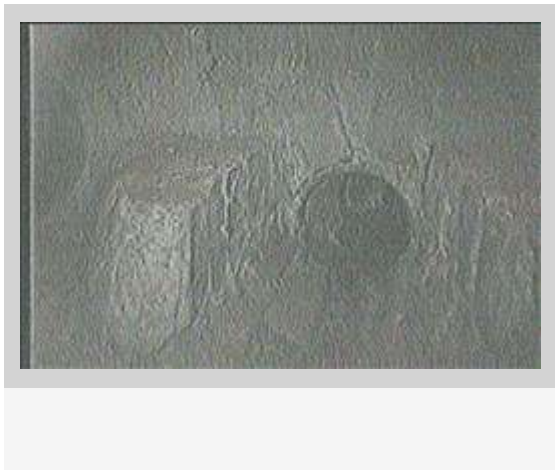
6 in. Circular Gravity Sewer
Pipe In @ 7 O'Clock

Infiltration: **Evidence** Pipe Seal Cond: **Cracked**
